# **Getting Your GMC Under Control**

Control Arm Presentation  
By Steve Ferguson

# 1973 GMC CONTROL ARMS

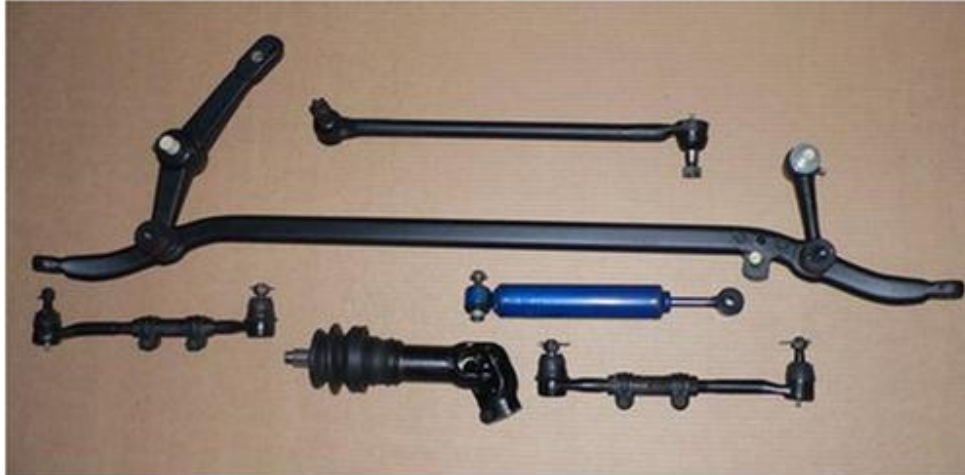
The newest GMC is 31 years old. Age and mileage take their toll in wear on suspension parts. By now, most GMCs have had some suspension components replaced. The following components are between the steering wheel and the knuckles. (The steering box and Pitman arm are not included in this photo.)

As you can see from the previous page out of the parts manual, there are a lot of moving parts in the steering system. System is the key word here. Like any system, unless every part works as designed, the system will suffer. In our case, if some parts of this system are worn or are in need of repair, the symptoms are poor handling.

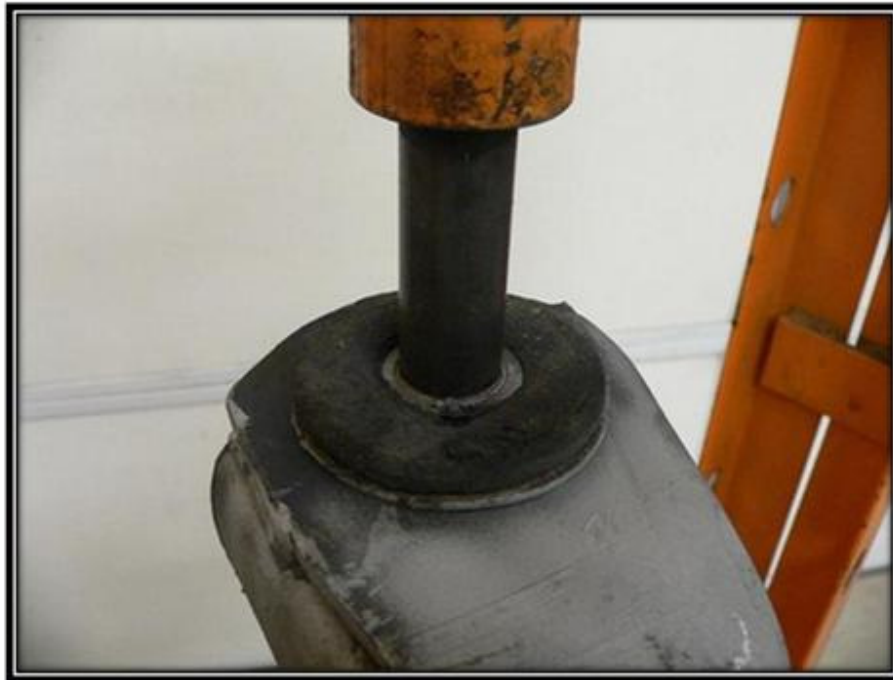
STEP 1  
PRESS OUT THE INNER SLEEVE

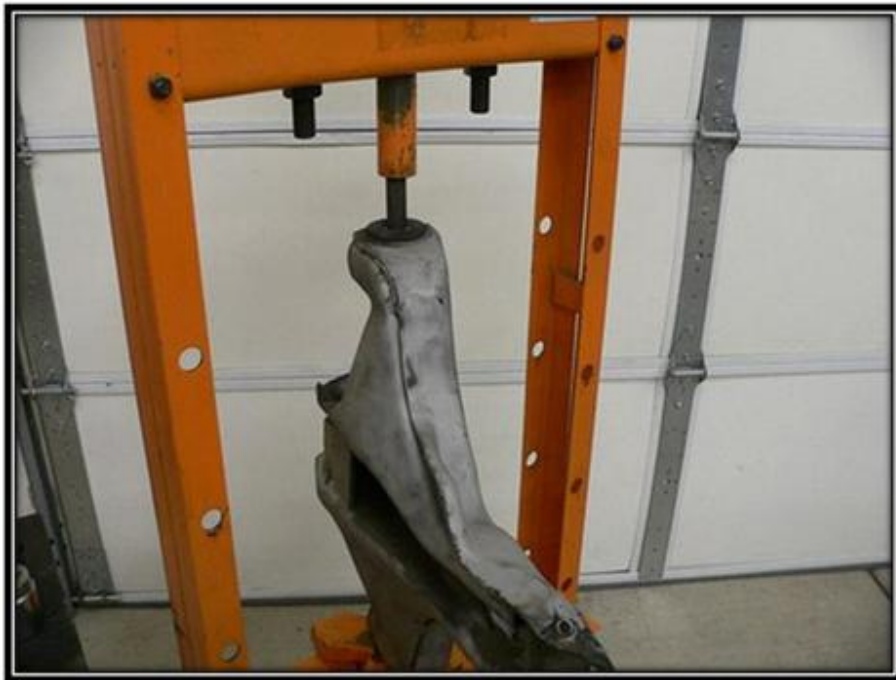
STEP 1  
DIFFERENT VIEW

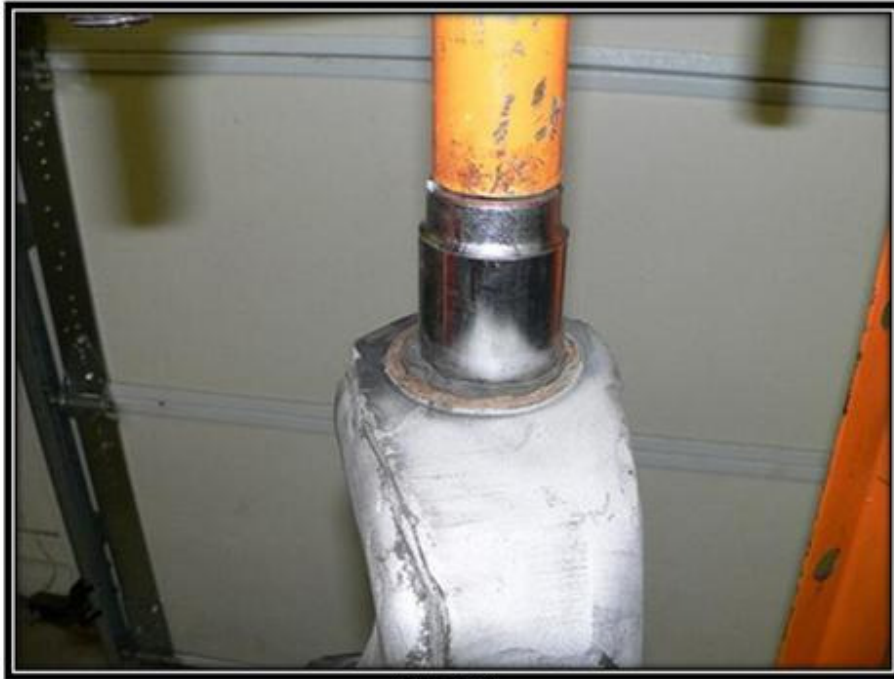
STEP 2  
USE A SOCKET OR ANYTHING SLIGHTLY  
SMALLER THAN THE ID OF THE SLEEVE, PRESS  
OUT THE OLD RUBBER

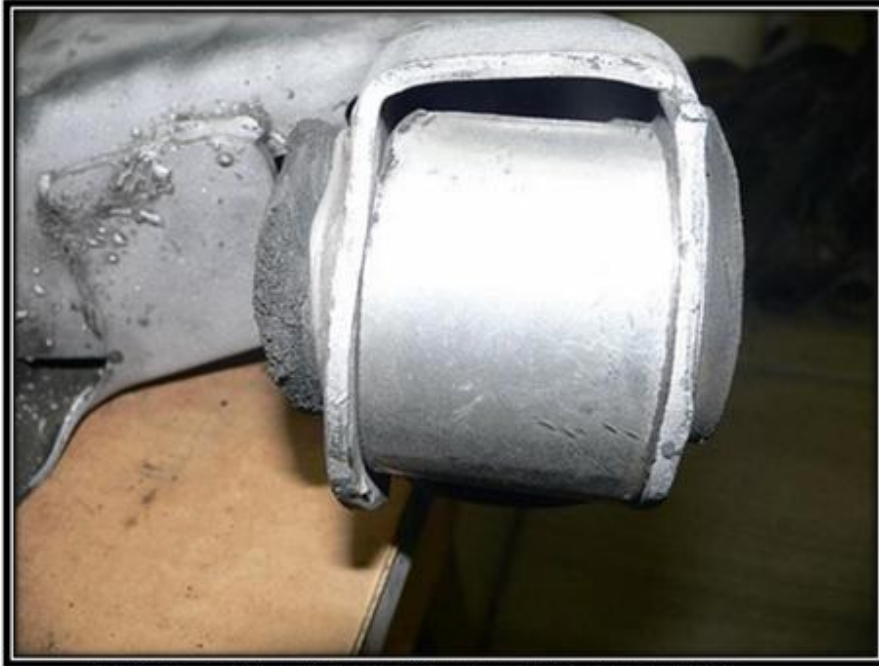
A NOTE HERE: IF YOU PLAN ON USING OEM STYLE RUBBER BUSHINGS, DO NOT ATTEMPT TO REMOVE THE OLD BUSHING WITHOUT THIS SPACER BETWEEN THE MOUNTING EARS.

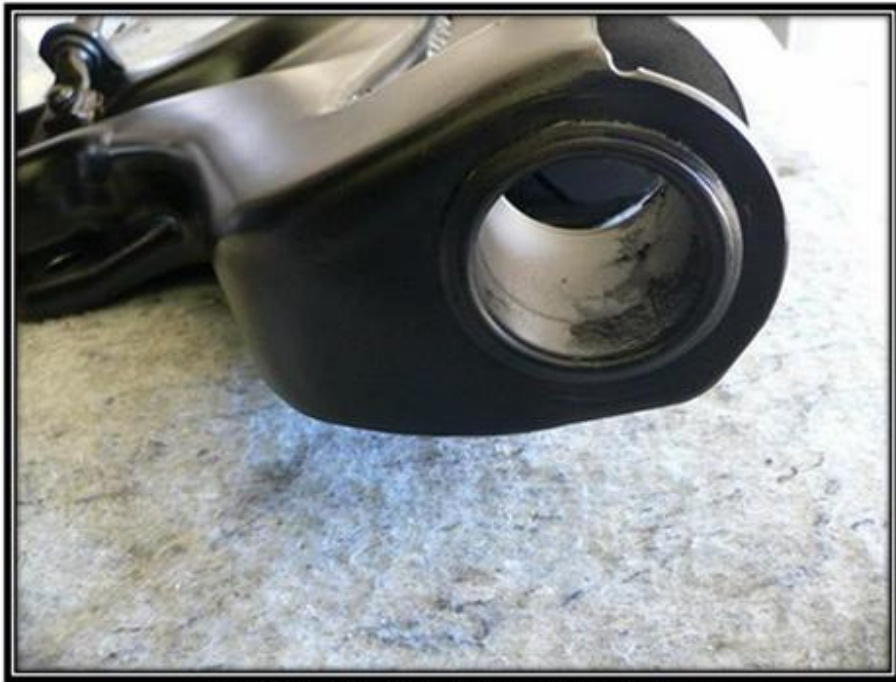
CLEAN OUT ALL THE OLD RUBBER

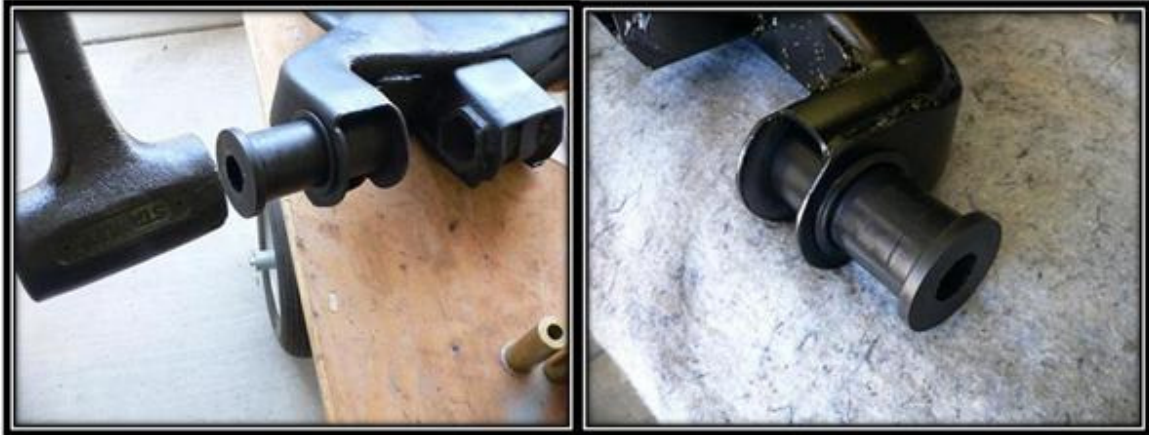
ABOUT 4 GOOD WHACKS WILL  
DRIVE HOME THE NEW  
URETHANE BUSHING

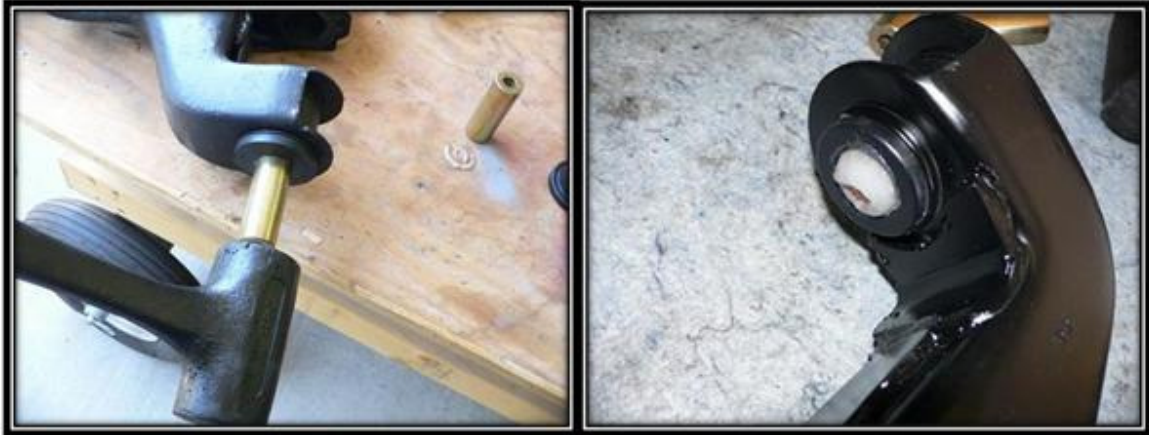
GREASE LIBERALLY WITH  
PROVIDED SILICONE, DRIVE  
THE INNER SLEEVE IN

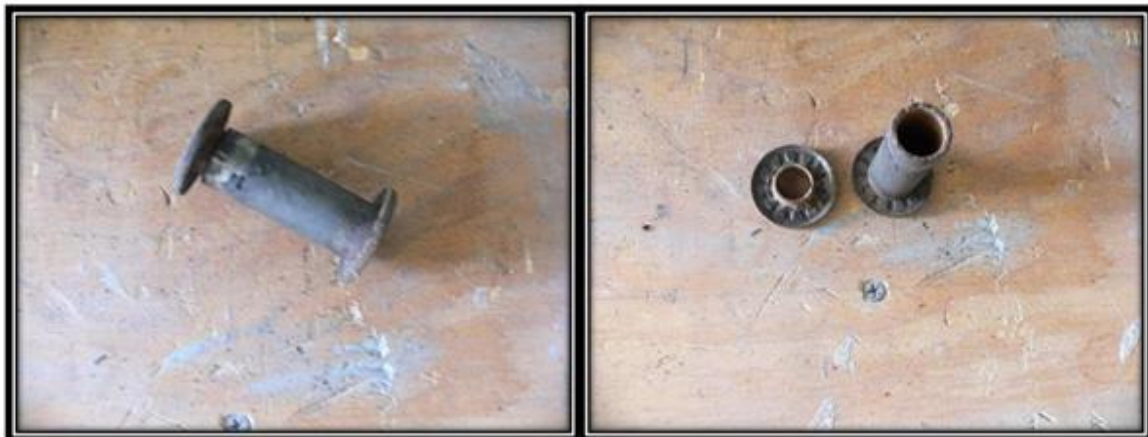
# UPPER INNER SLEEVE AND END WASHERS ARE REUSED FOR URETHANE

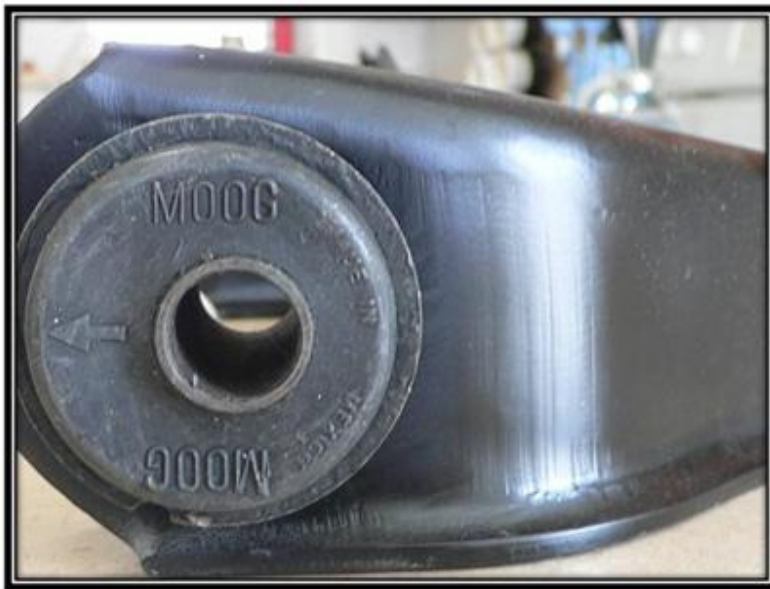
### **Offset bushing/Upper control arm**

This is the right side, upper control arm, rear bushing. Note that this is installed for additional caster adjustment. By installing offset bushing in this manner (arrow pointing away from the ball joint) you should pick up 2 deg of additional caster. Only one offset per arm is really needed.
